FM-200 SYSTEM SAVES LASER ROOM PRODUCTION

NO NEED FOR SPRINKLER ACTIVATION

Monday July 6th, 2020 A Major Medical Manufacture in Connecticut had a fire inside a laser room where production of medical components is produced. The fire was quickly extinguished by an FIKE FM-200 – Clean Agent Fire Suppression System.

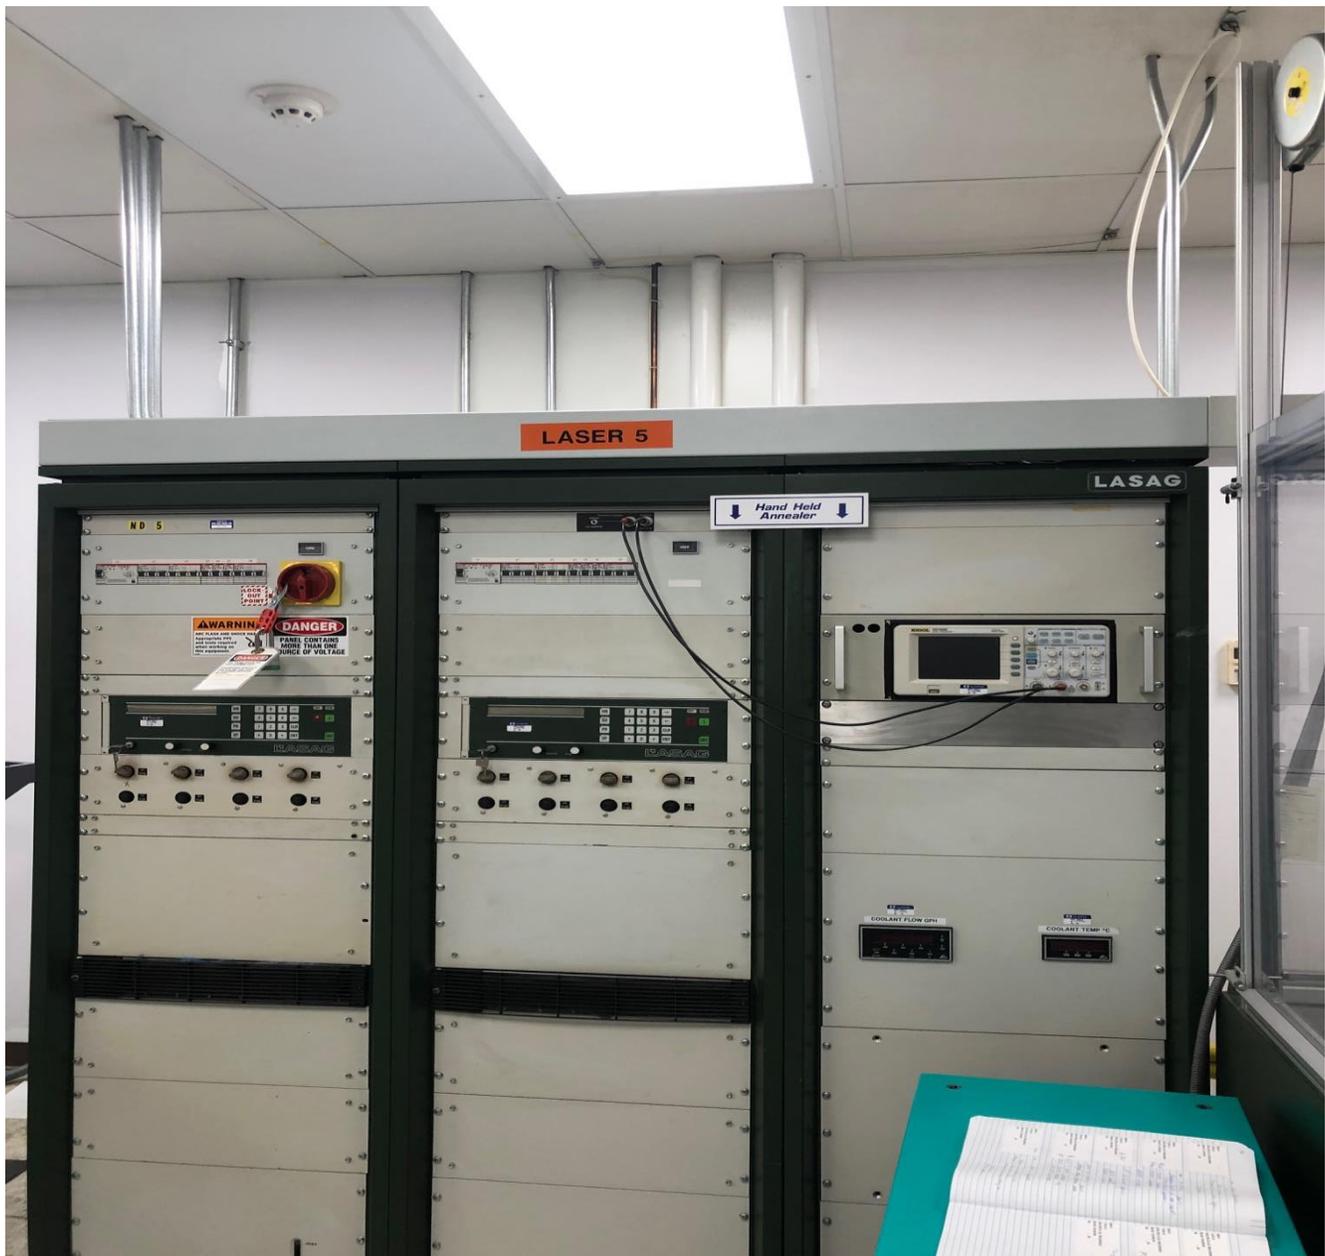
As you can see in the picture, the laser electrical cabinet to the left that has a lock-out / tag-out attached, was the cabinet that caught fire. The wiring and data card located inside the cabinet started to smolder and catch fire. One of the detectors, seen above the series of cabinets in the photo, detected the first amount of smoke, sounded a bell alarm, and initiated the building fire alarm. A second detector to the side of the cabinets identified another presence of smoke, sounded a horn/strobe alarm, initiated a 30 second count-down and laser power shutdown from relays associated with this system. Personnel exited as per their emergency response protocol. The FM-200 expelled into the protected space and quickly extinguished the fire in laser room #2.

As you can see there was no fall-out from the FM-200 discharge and the client was able to resume production without any water damage since the sprinkler system did not have to function.

The client contacted FPS which responded within one-hour to initiate system re-commissioning.
